**WORLD CLASS
MAINTENANCE**

CUI Case Description.

Cost-effective proactive CUI Management; wish or truth?

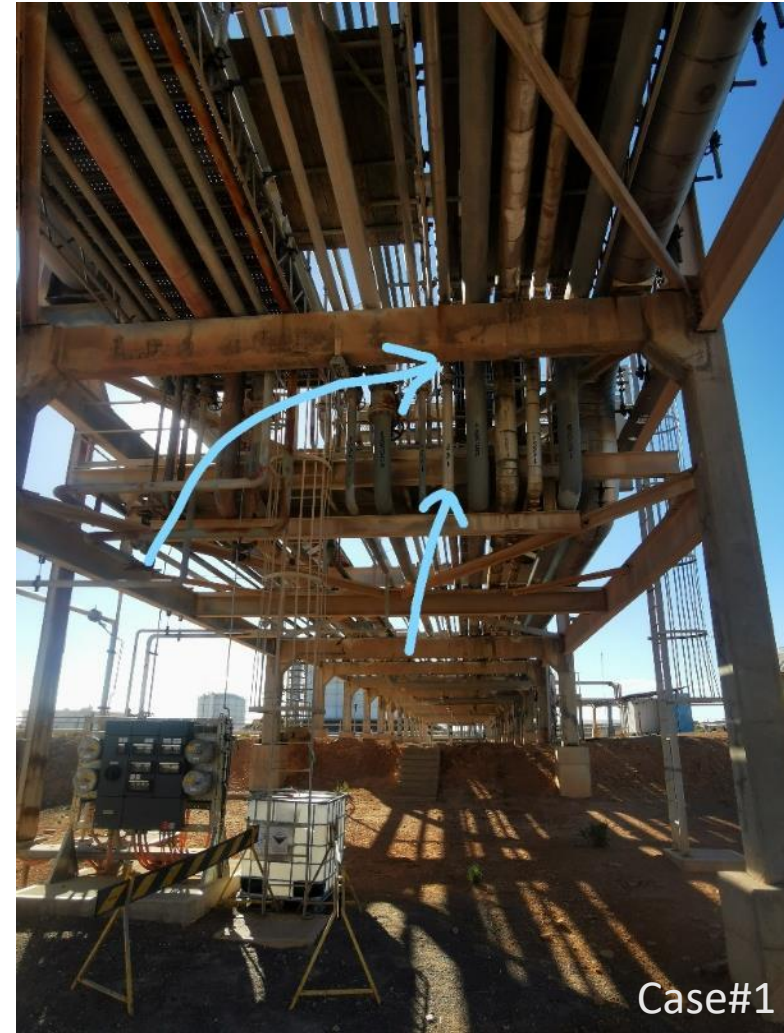
Where was it?

Inspection program on a piping-bridge
No failure in this case
Serious doubts in general

- Hard to reach
- Enclosed in other piping
- Scaffolding required
- No sight from lower level

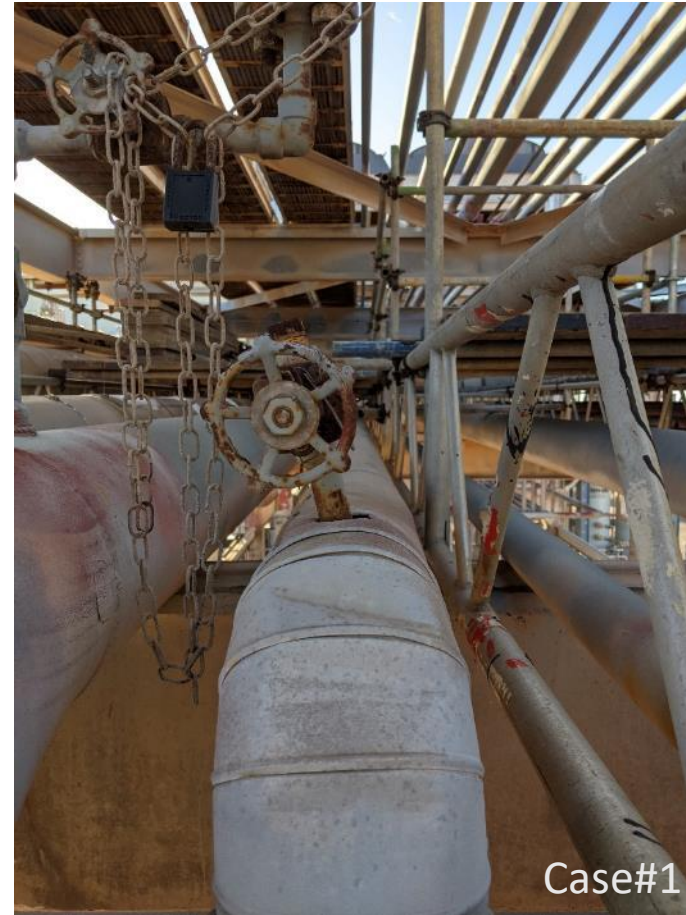
What about the insulation?

- Insulation dented
- Connections still in place
- Connection hand-valve as built
- However: water ingress possible
- → condition class: 3 (4)

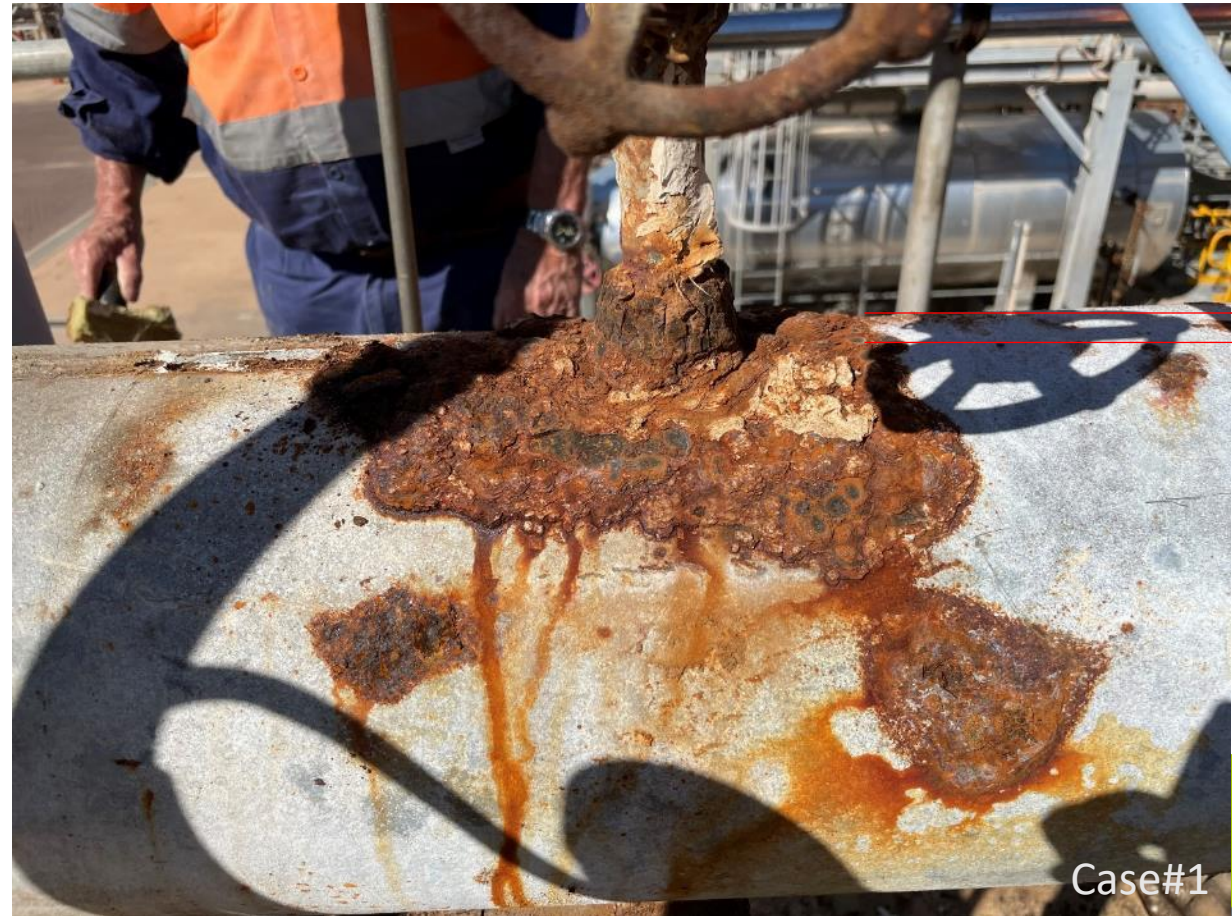
What after stripping?

- Very localized attack
- Thick corr. layer D
- => D/10 thickness gone
- Remaining thickness?

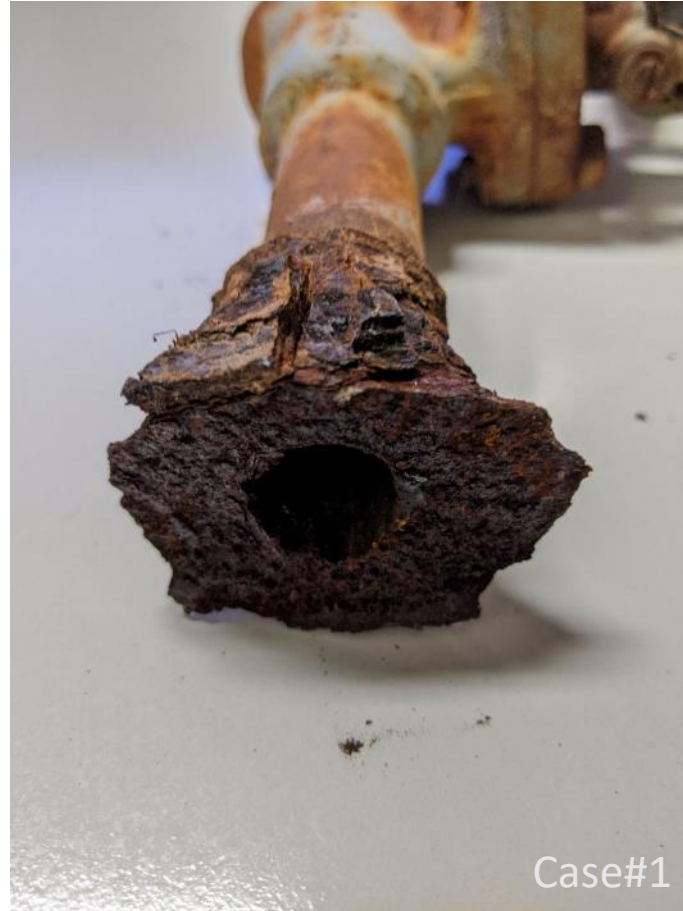
What about the integrity?

Connection failed:

- Corroded through the wall
- Complete failure
- No remaining thickness
- Lucky escape!!!

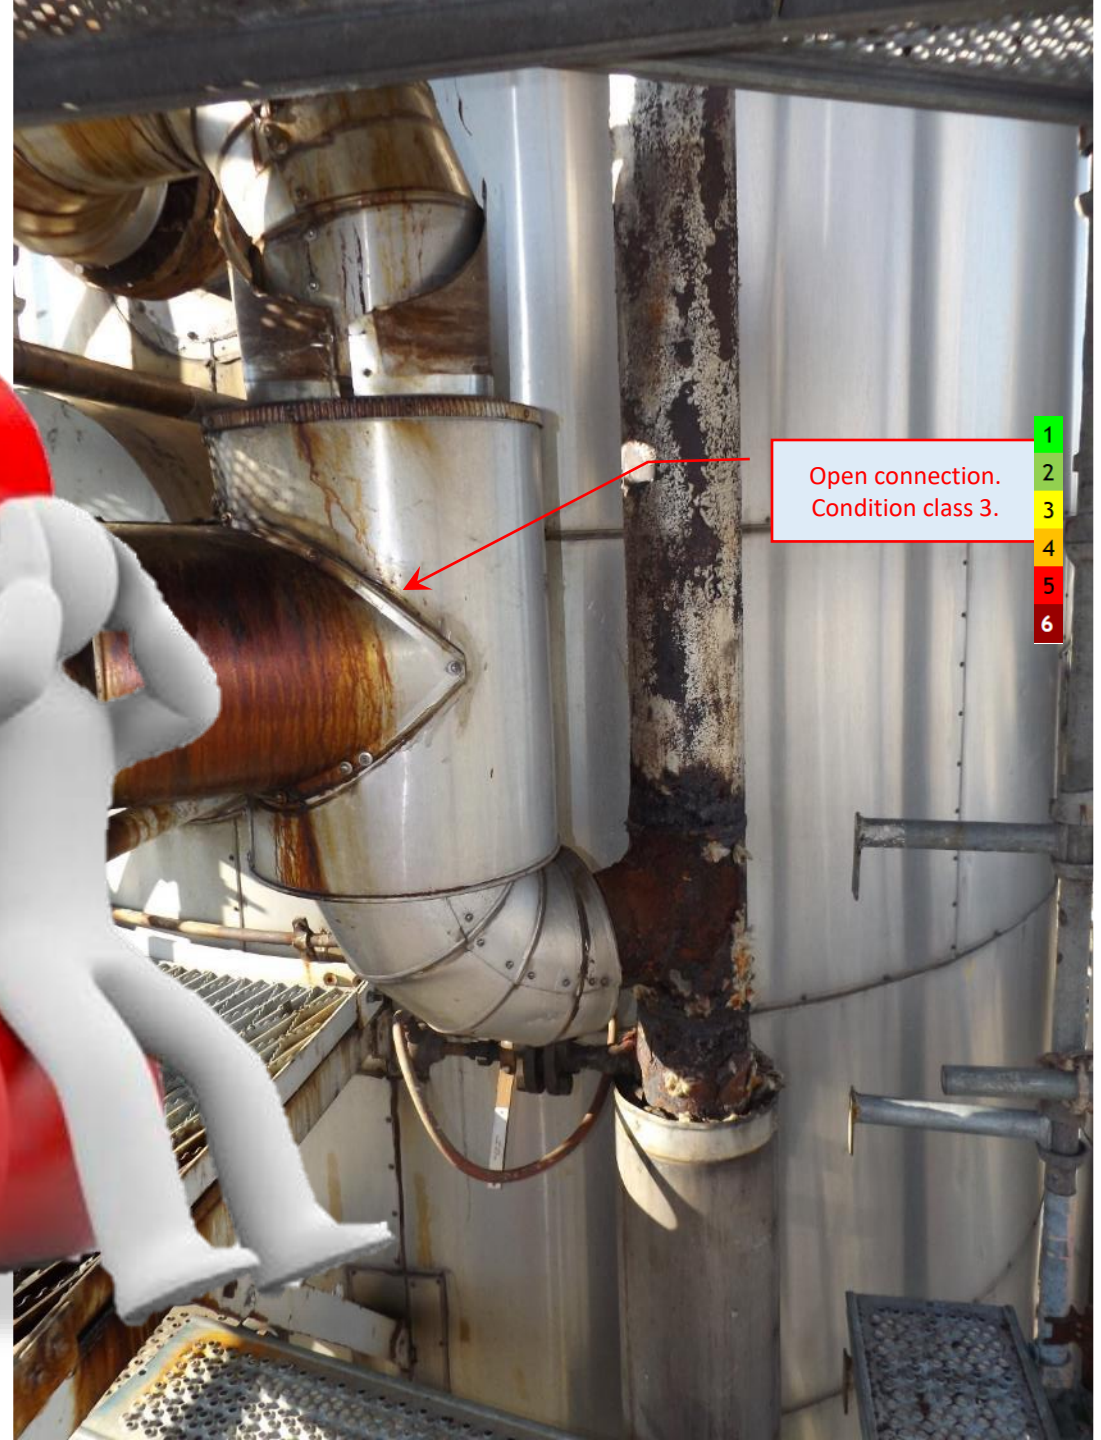
UITWENDIG AANTASTING

Open connection.
Condition class 3.
