**WORLD CLASS
MAINTENANCE**

CUI Case Description.

Cost-effective proactive CUI Management; wish or truth?

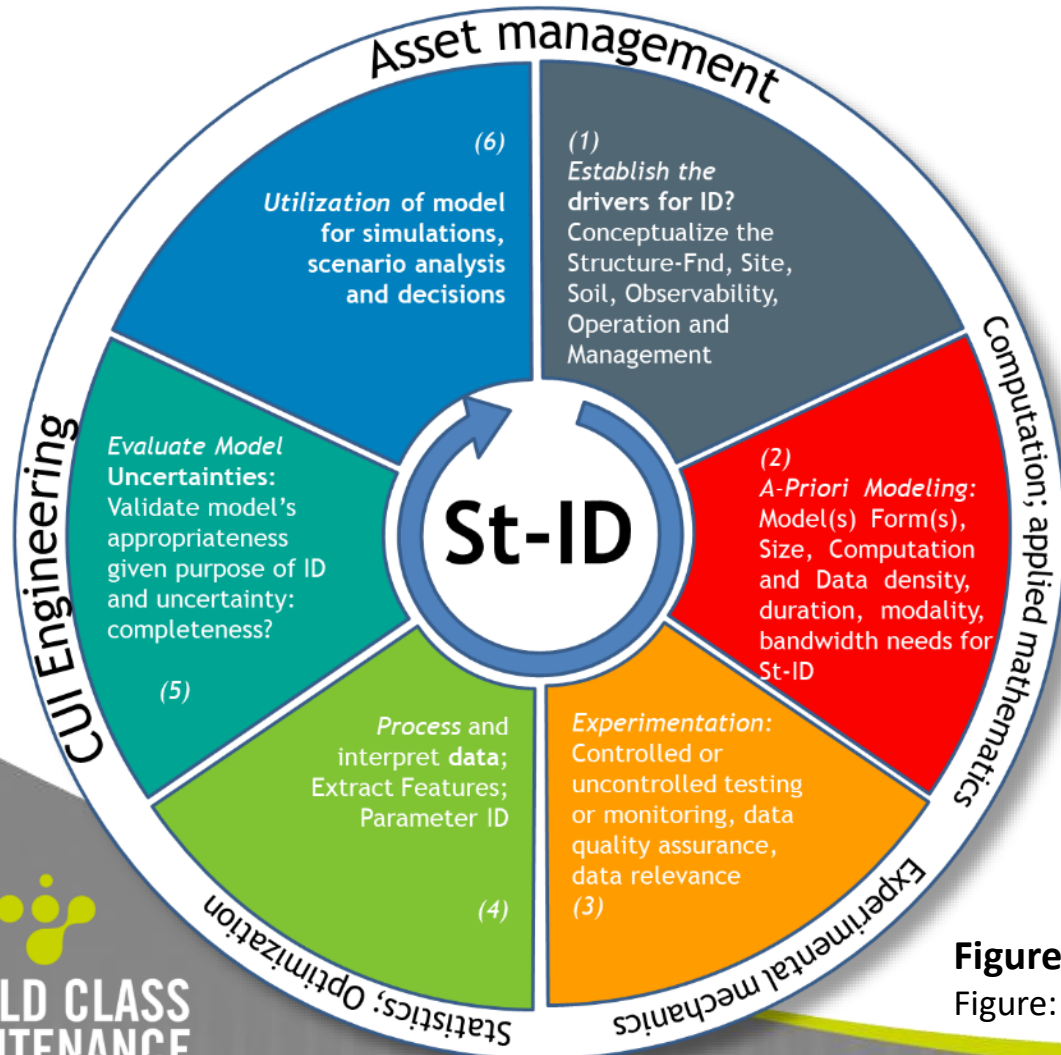
Figure: Grip on CUI by means of managing the key parameters

- Figure shows critical elements for effective Asset management.
- These elements are to be linked to themes in a development, in order to ensure the effectivity of the approach
- Management concept is based on controlling CUI by controlling these themes.
- Key issue: *use an explicit model in order to be able to manage developments.*
